# HISTORIC DISTRICT COMMISSION MEETING AGENDA

Monday, July 13, 2026 – 6:00 P.M.  
Council Chambers – City Hall  
300 West Crowell Street - Monroe, NC

# Roofing Inspection Report

**109 North College Street, Monroe NC 28112**

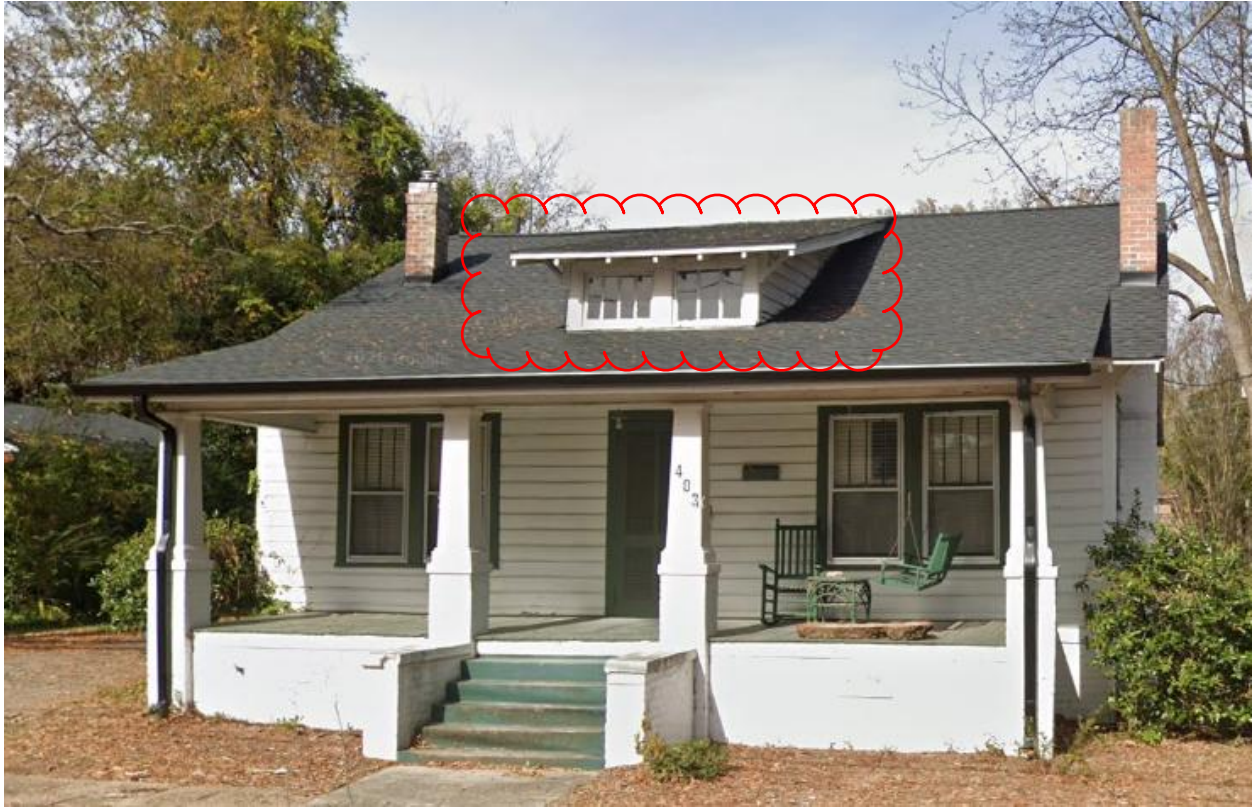
Exhibit 5

The windows that were removed were not original to the house. They were mismatched in style and condition, and many had significant rot, water intrusion, and leakage. Due to their deteriorated condition, replacement was necessary.

Previous Wood Windows

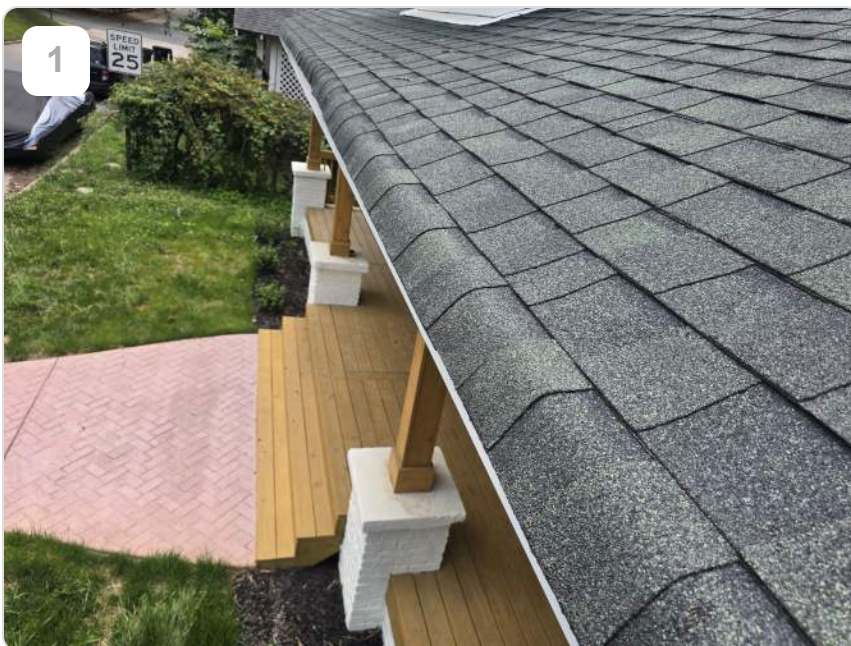
Moderate

**Status:** Monitor

Excessive shingle overhang was observed at the roof edge. The overhang measured approximately 4 inches, exceeding the recommended maximum of 1.5 inches. This condition may increase the risk of wind damage and should be corrected by a qualified roofing contractor.

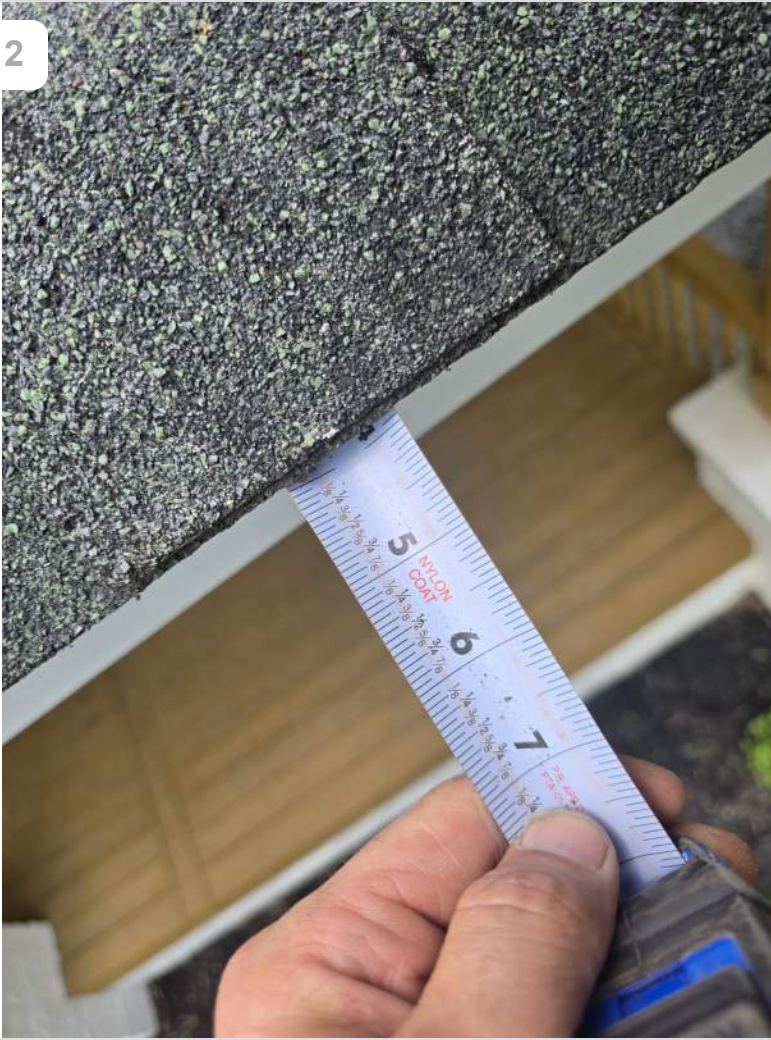
2

Moderate

**Status:** Monitor**Description:**

Excessive shingle overhang was observed at the roof edge. The overhang measured approximately 4 inches, exceeding the recommended maximum of 1.5 inches. This condition may increase the risk of wind damage and should be corrected by a qualified roofing contractor.

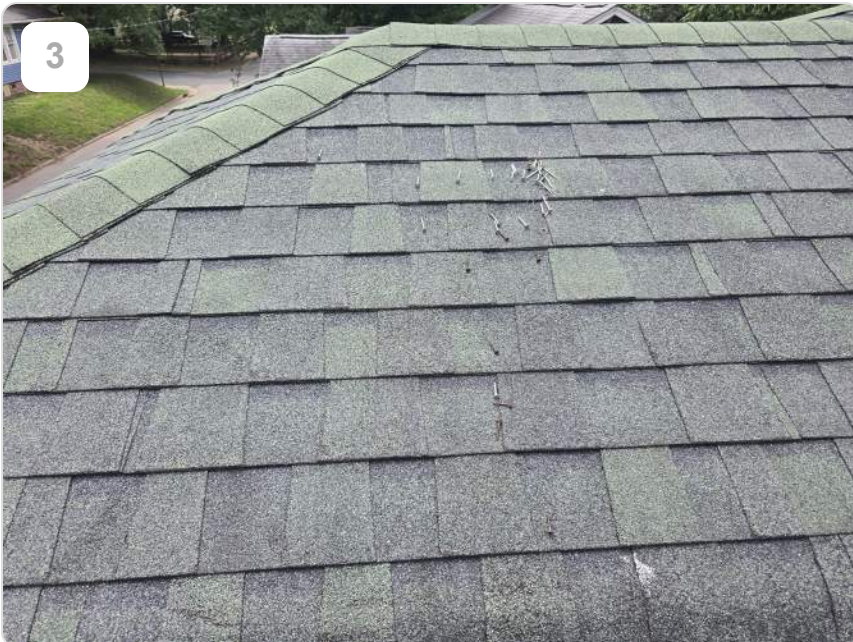
3

Minor

**Status:** Monitor**Description:**

Loose nails and roofing debris were observed on the roof surface. These materials appear to have been left behind during the roofing installation and should be removed to maintain proper roof condition and prevent potential damage.

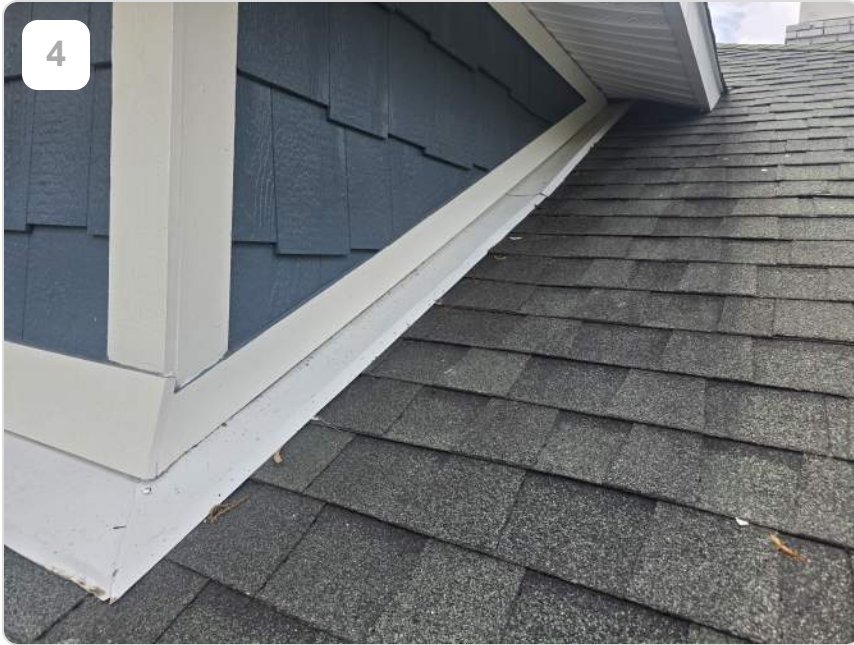
**Urgent**

**Status:** Needs Repair

Apron flashing was observed along the sidewall transitions where step flashing is typically required. Due to the concealed nature of the installation, it could not be determined whether proper step flashing was installed beneath the apron flashing at the time of inspection.

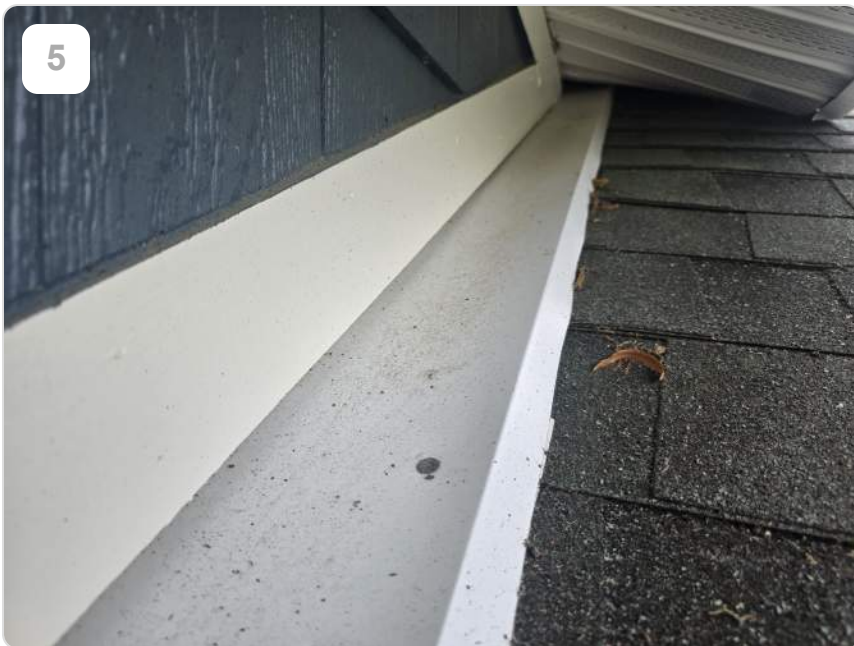
**Moderate**

**Status:** Needs Repair

Exposed fasteners were observed in the apron flashing. This condition was present throughout the flashing installation and should be properly corrected to prevent potential water intrusion.

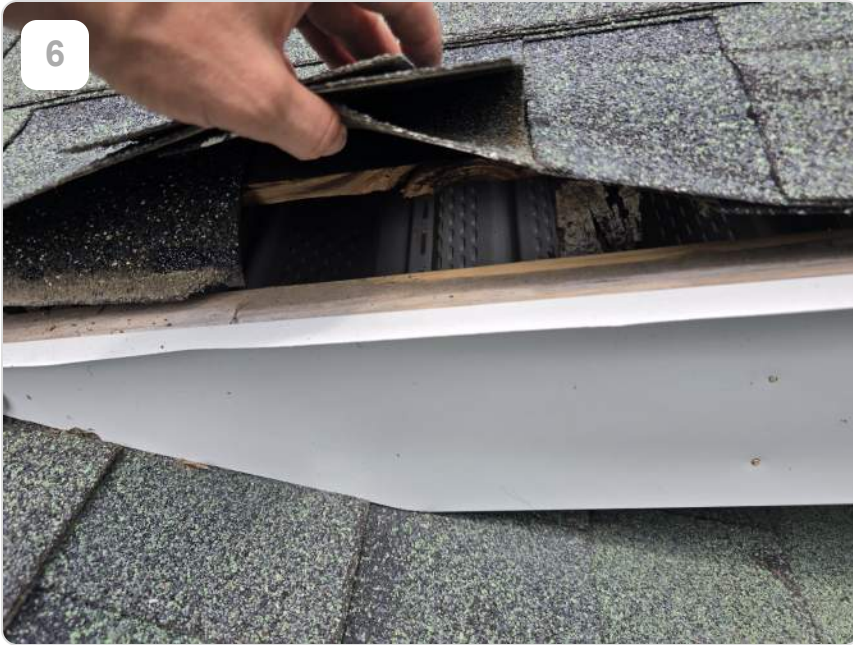
6

**Urgent**

**Status:** Needs Repair

A large builder's gap was observed at the roof edge. The shingles do not provide adequate overhang, leaving portions of the wood substrate exposed to the elements. This condition may contribute to moisture-related deterioration and can provide access for pests and animals to enter and nest within the structure.

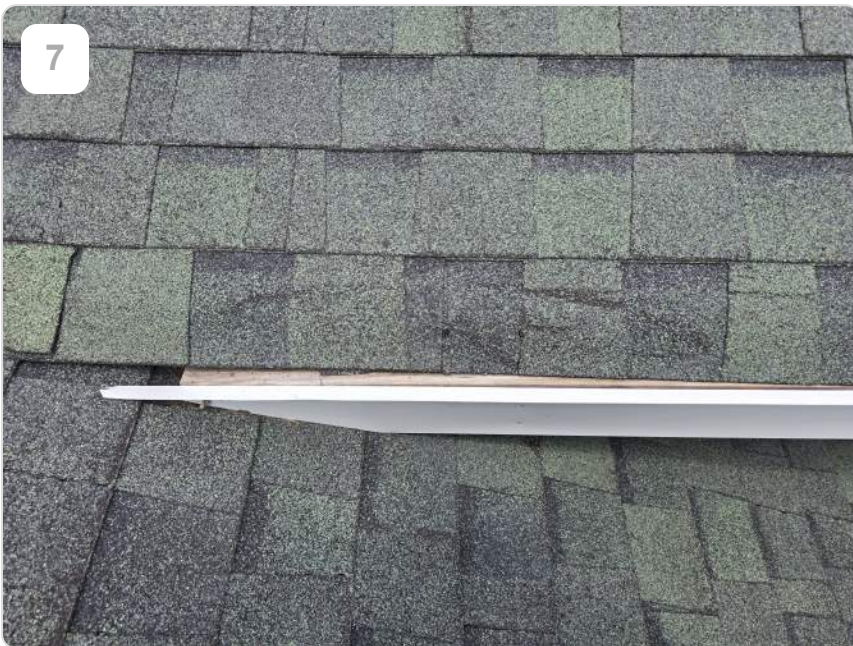
7

**Urgent**

**Status:** Needs Repair

Damaged shingles and exposed fascia were observed. Without proper shingle overhang, these areas are vulnerable to moisture intrusion and potential wood rot. Correction is recommended.

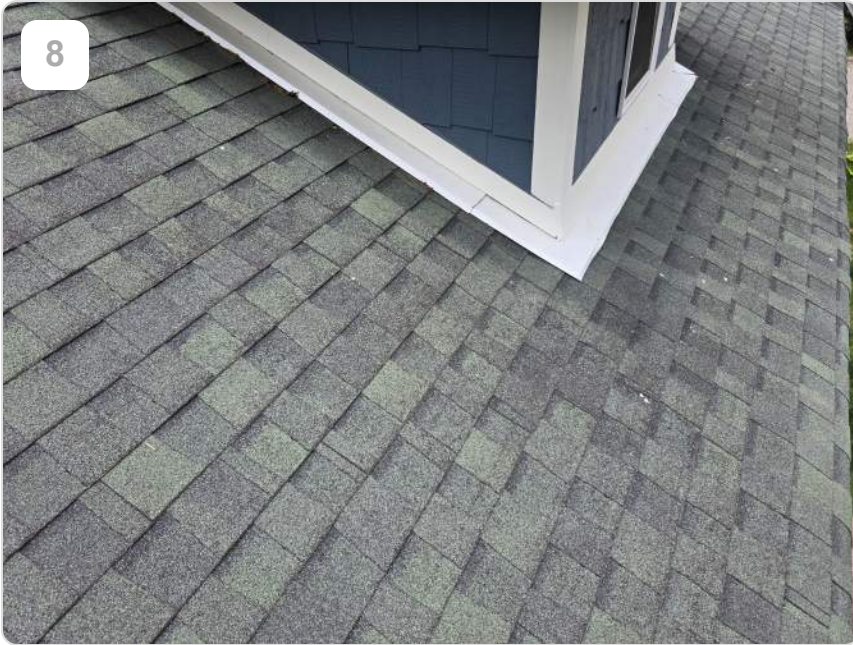
8

Moderate

Heavy foot traffic was observed around the dormer area, resulting in significant granule loss and premature wear of the affected shingles.

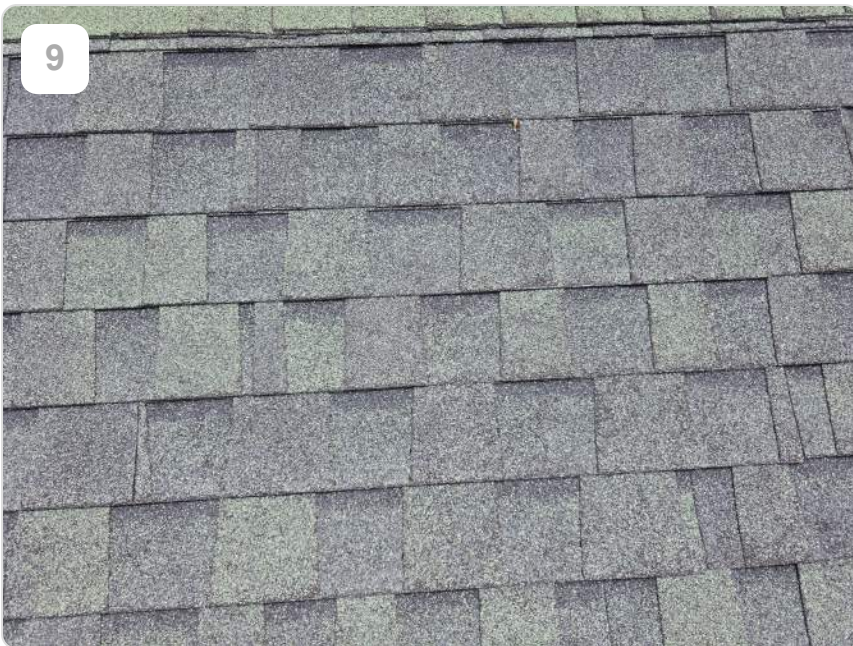
9

Urgent

Shingles exhibiting excessive wear and granule loss should be replaced to maintain the roof's integrity and weather resistance.

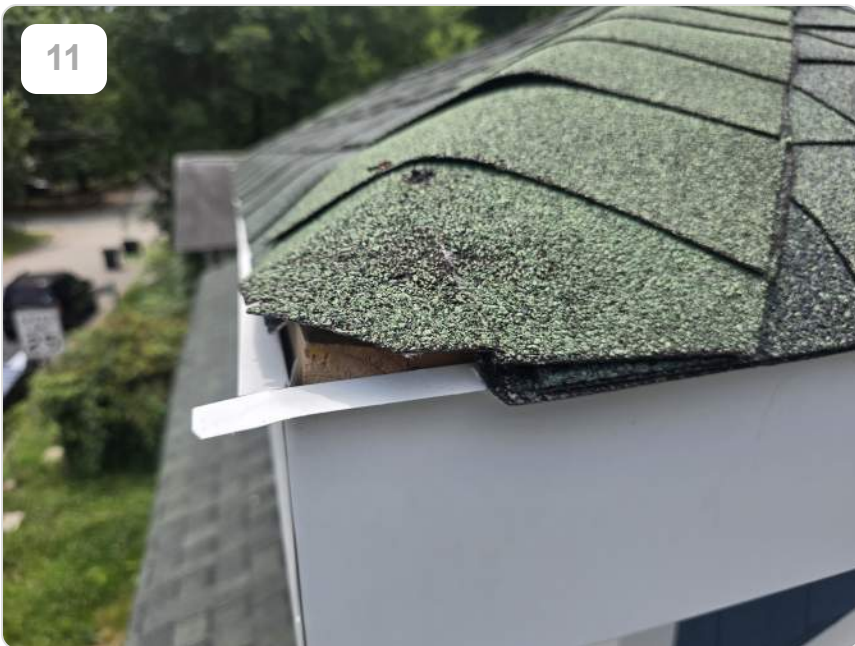
**Urgent**

**Status:** Needs Repair

Torn hip cap shingles were observed. Damaged hip caps should be replaced to maintain proper weather protection and prevent potential water intrusion.

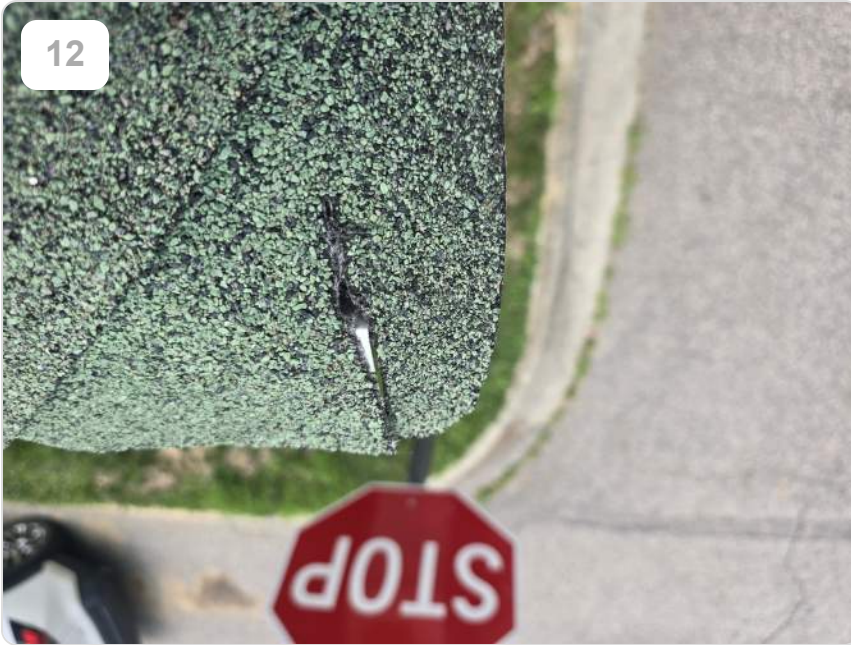
12

**Urgent**

**Status:** Needs Repair

Torn hip cap shingles were observed. Damaged hip caps should be replaced to maintain proper weather protection and prevent potential water intrusion.

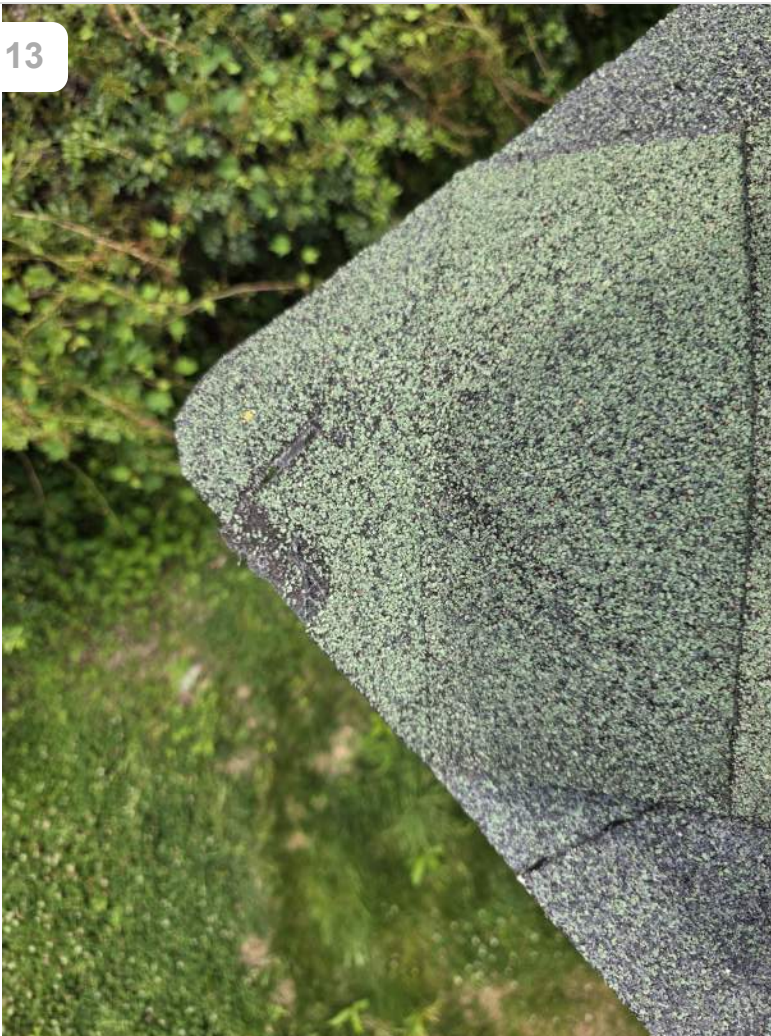
13

**Urgent**

**Status:** Needs Repair

Torn hip cap shingles were observed. Damaged hip caps should be replaced to maintain proper weather protection and prevent potential water intrusion.

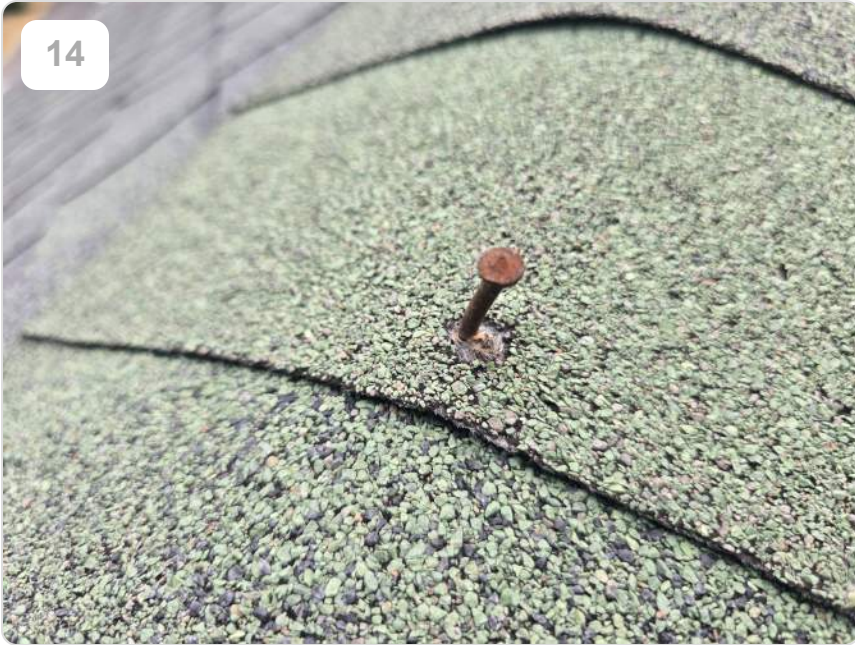
14

**Urgent**

**Status:** Needs Repair

Exposed fasteners were observed on the hip caps. These fasteners should be properly sealed or corrected to prevent potential water intrusion.

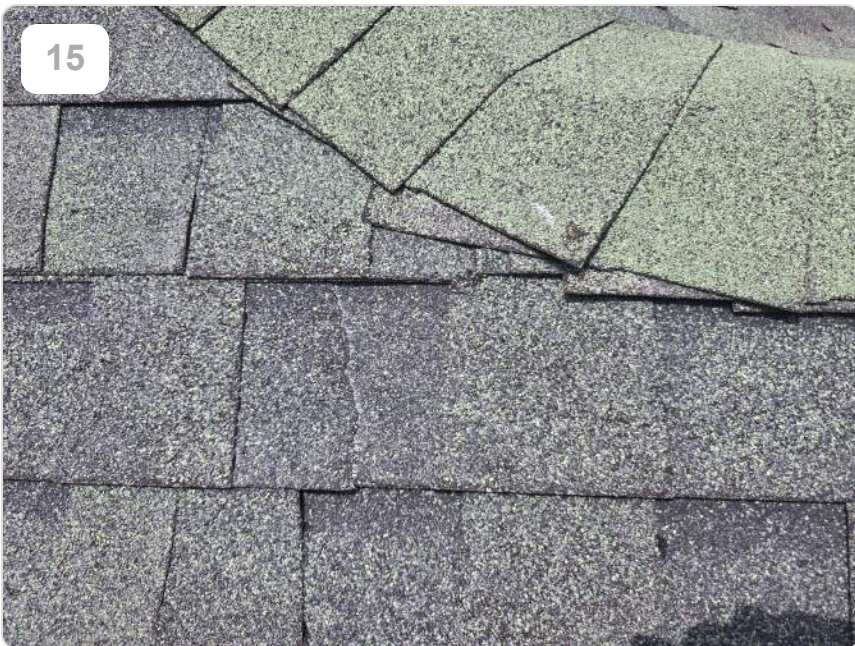
15

**Urgent**

**Status:** Needs Repair

Exposed fasteners were observed on the hip caps. These fasteners should be properly sealed or corrected to prevent potential water intrusion. Also cracked shingles

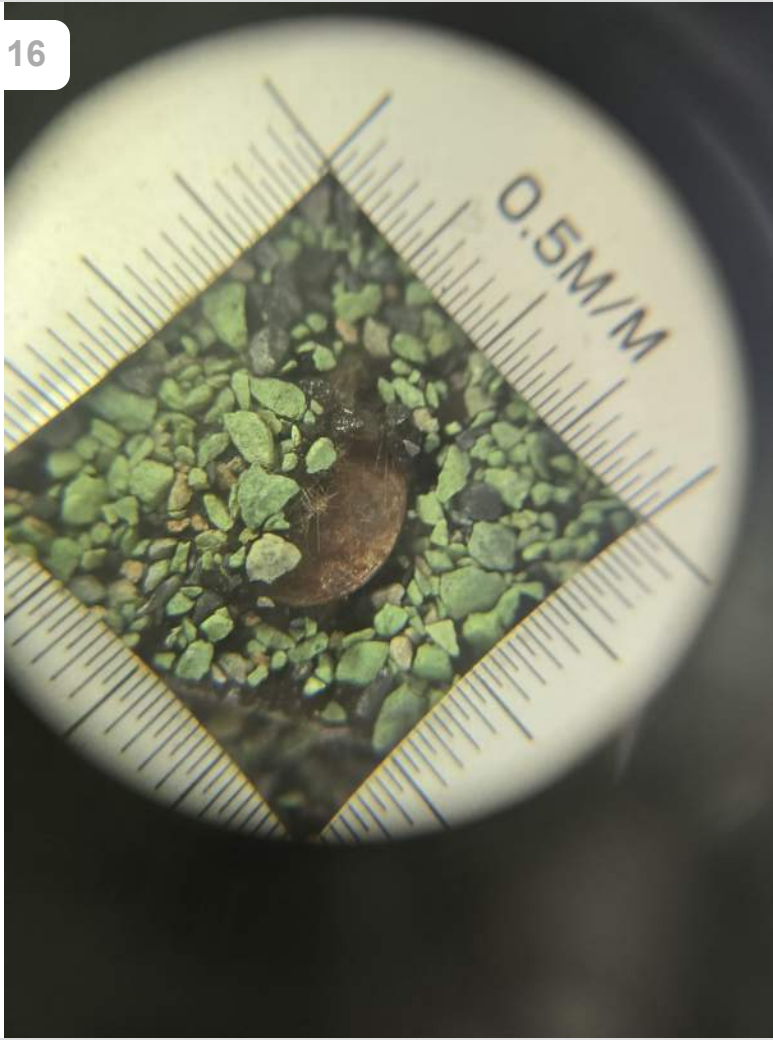
16

**Urgent****Status:** Needs Repair**Description:**

Multiple nail pops were observed throughout various areas of the roof. These conditions should be addressed to prevent shingle damage and potential water intrusion.

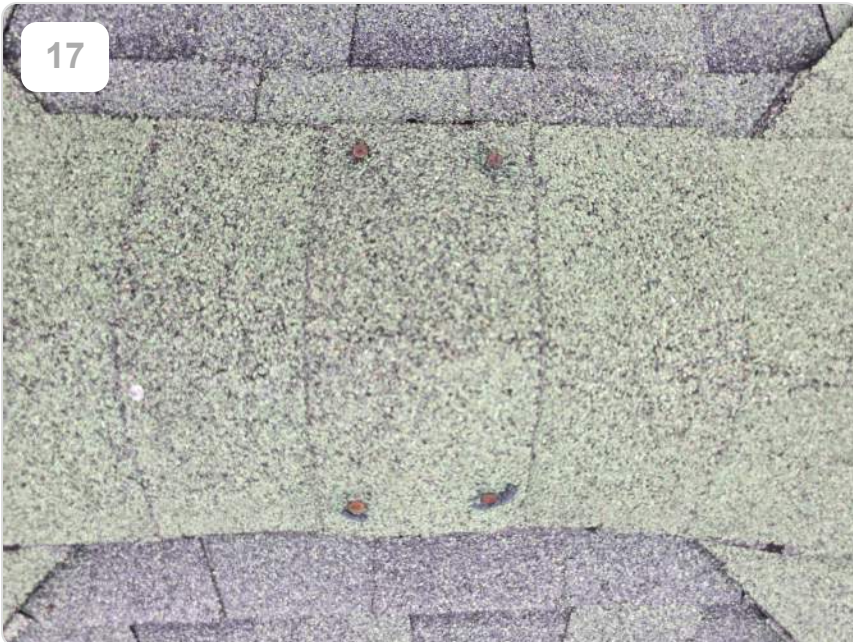
17

**Urgent****Status:** Needs Repair**Description:**

Multiple nail pops were observed throughout various areas of the roof. These conditions should be addressed to prevent shingle damage and potential water intrusion. No ridge vent present on ridge vents

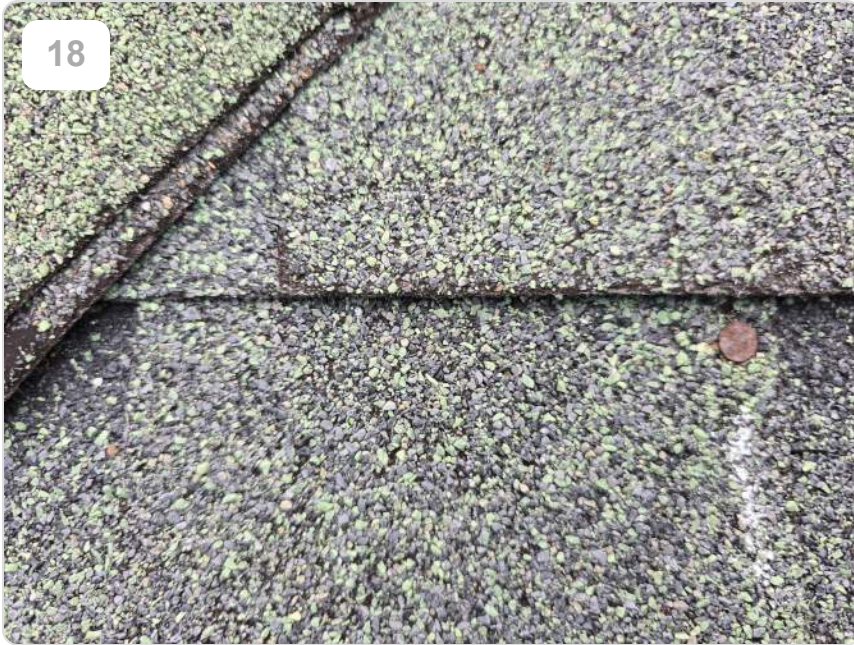
**Urgent**

**Status:** Needs Repair

Multiple nail pops were observed throughout various areas of the roof. These conditions should be addressed to prevent shingle damage and potential water intrusion.

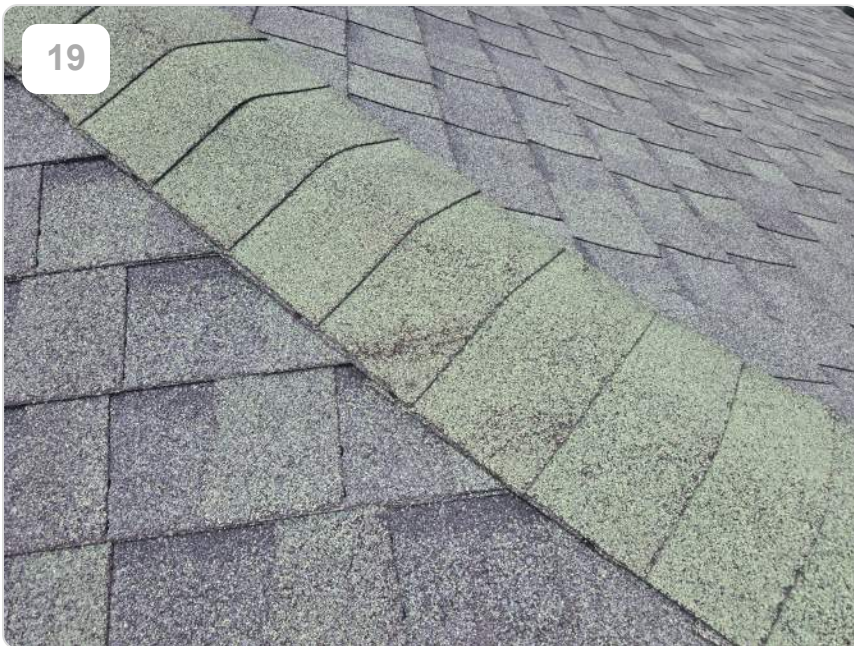
**Urgent**

**Status:** Needs Repair

Heavy granule loss, blistering, and wind-related damage were observed on the hip cap shingles. The affected areas exhibit advanced wear and should be repaired or replaced to maintain proper weather protection.

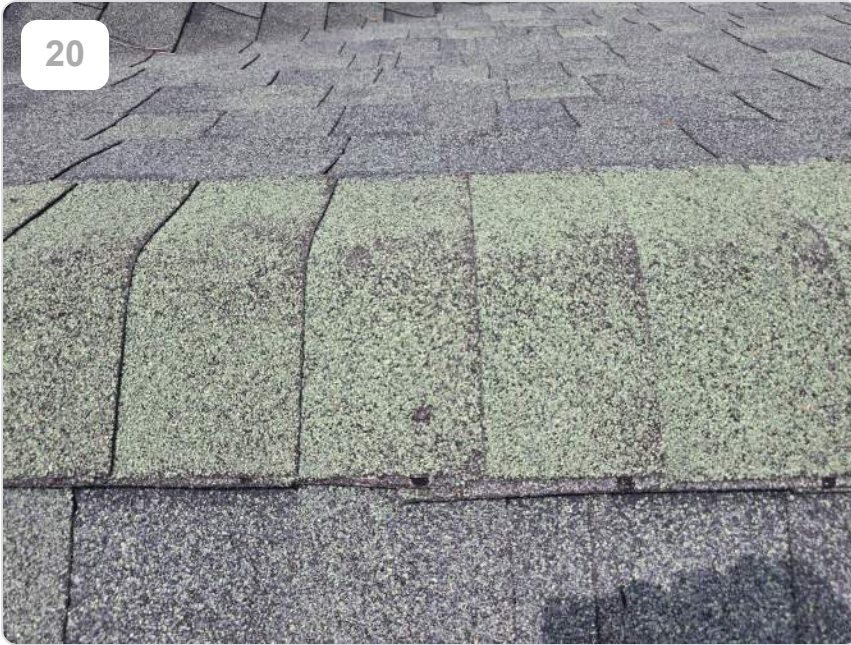
20

**Urgent**

**Status:** Needs Repair

Heavy granule loss, blistering, and wind-related damage were observed on the hip cap shingles. The affected areas exhibit advanced wear and should be repaired or replaced to maintain proper weather protection.

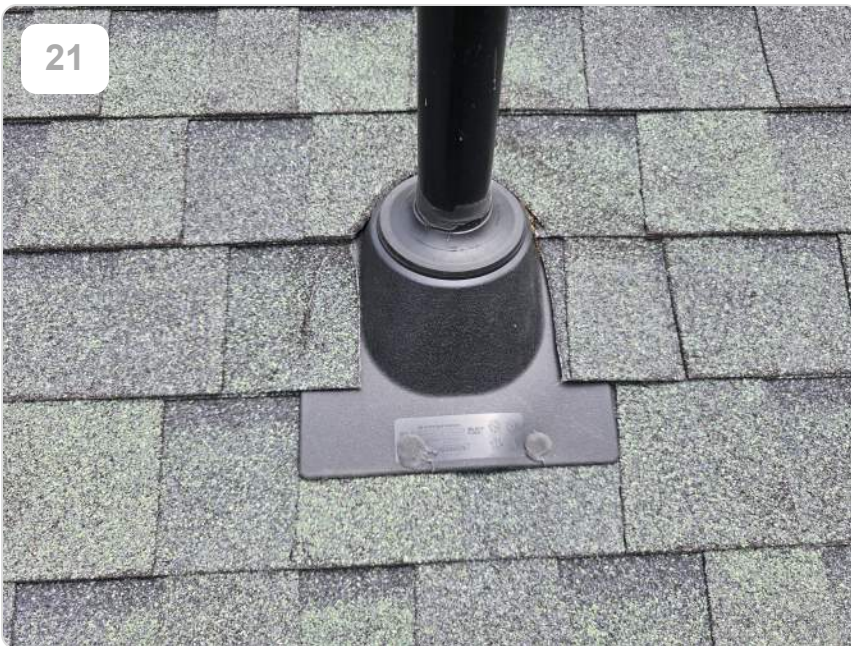
21

**Moderate**

**Status:** Monitor

The pipe jack flashings appear to have been replaced in the past; however, the surrounding shingles were not replaced and exhibit damage consistent with the previous repair work. Replacement of the affected shingles is recommended to maintain proper weather protection.

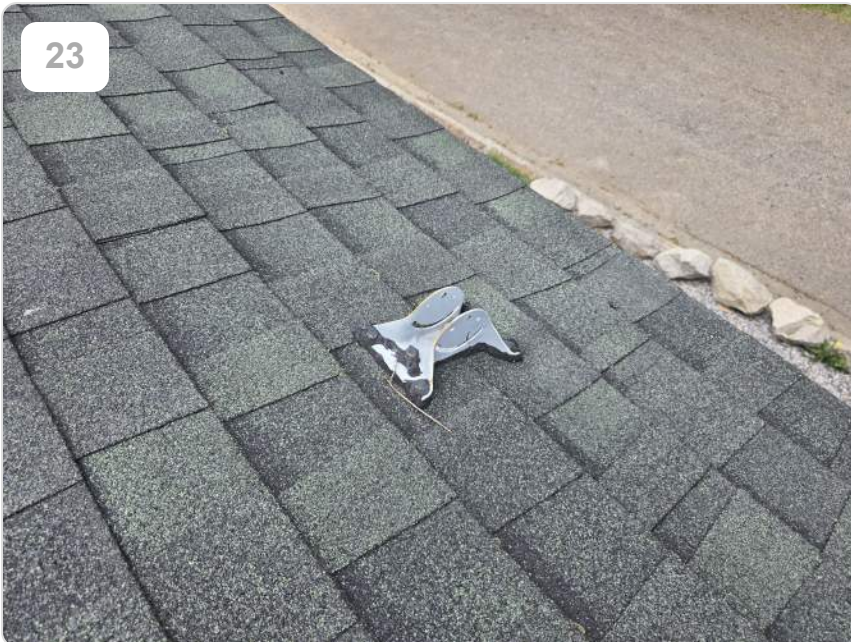
23

Urgent

**Status:** Needs Repair**Description:**

The satellite mounting bracket was found to be loose at the time of inspection. This condition may allow water intrusion around the mounting penetrations and should be properly secured and sealed.

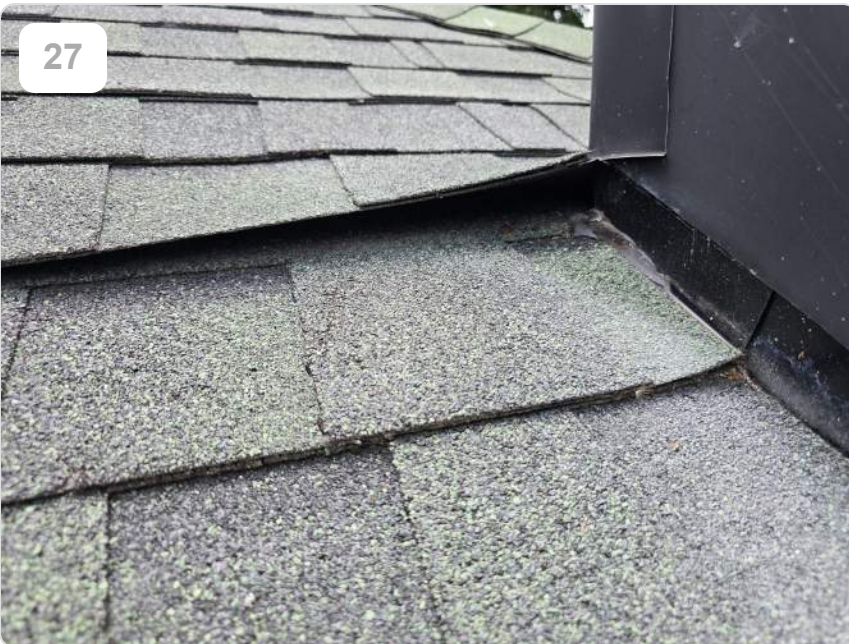
**Urgent**

**Status:** Needs Repair

Improper chimney flashing installation was observed. Visible fasteners were present within the flashing system, and adjacent shingles were lifted. These conditions may allow water intrusion and should be corrected to ensure proper weather protection.

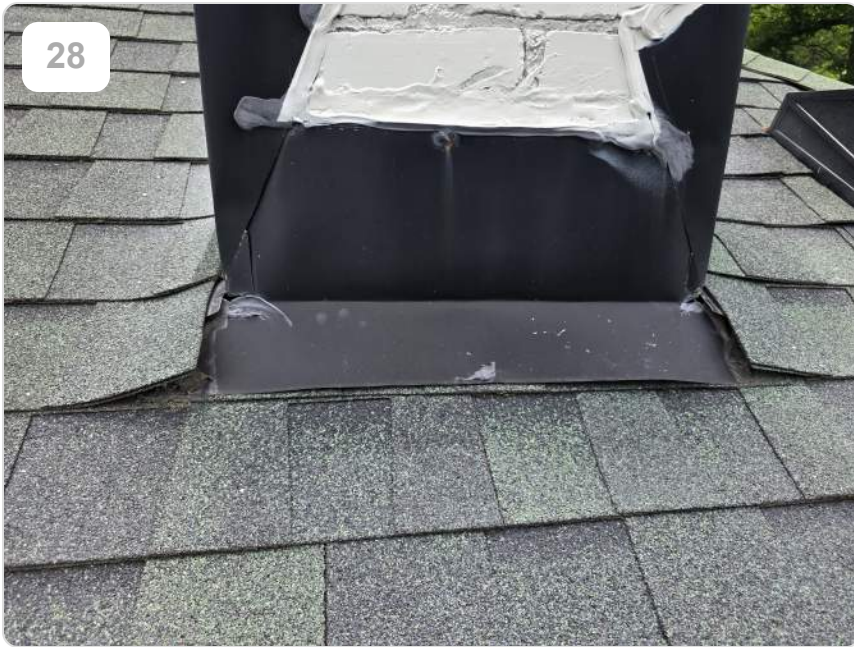
**Urgent**

**Status:** Needs Repair

Improperly installed counter flashing was observed at the chimney. The flashing does not appear to be installed in accordance with standard roofing and masonry practices and should be corrected to ensure proper water diversion and weather protection.

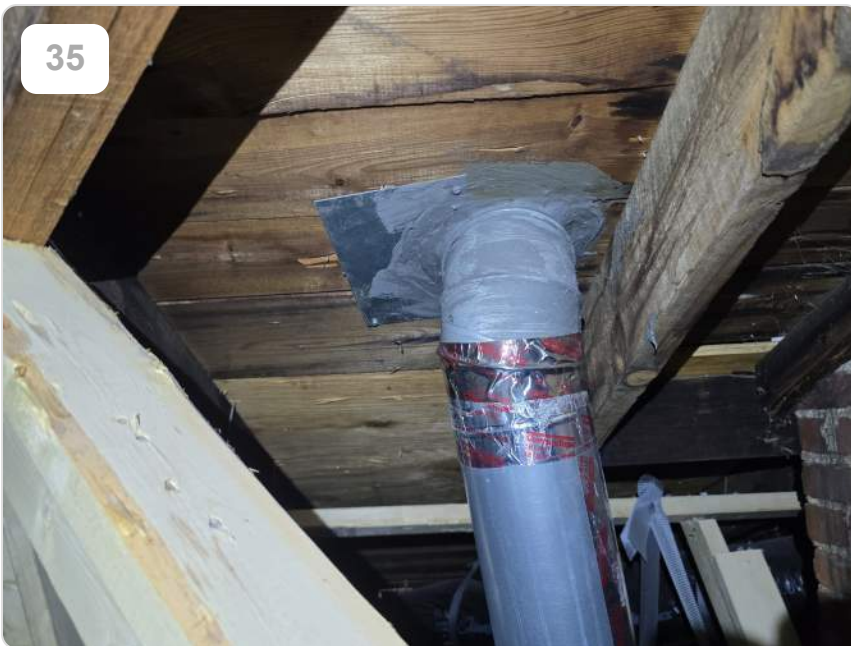
**Urgent**

**Status:** Needs Repair

The exhaust vent penetration appears to have been sealed from the interior side of the roof deck. Repairs of this nature are not recommended, as they can conceal active leaks and trap moisture within the roof assembly. Any water intrusion occurring at the penetration may go undetected, potentially leading to wood deterioration, mold growth, and further structural damage. Proper repairs should be made from the exterior using approved flashing and weatherproofing methods.

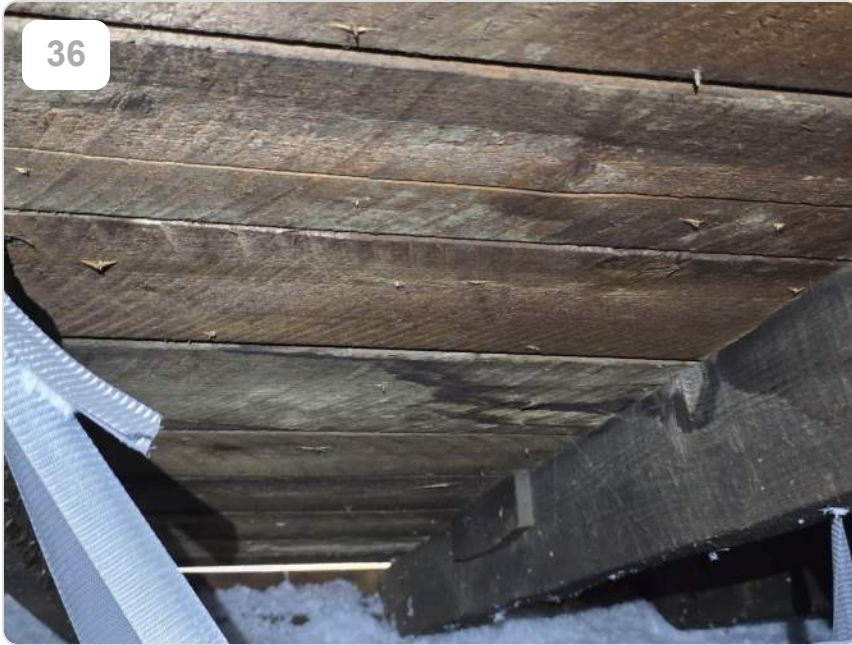
36

Moderate

Visible water staining was observed within the attic. The staining is indicative of past or ongoing moisture intrusion and should be further evaluated to determine the source and extent of any underlying damage.

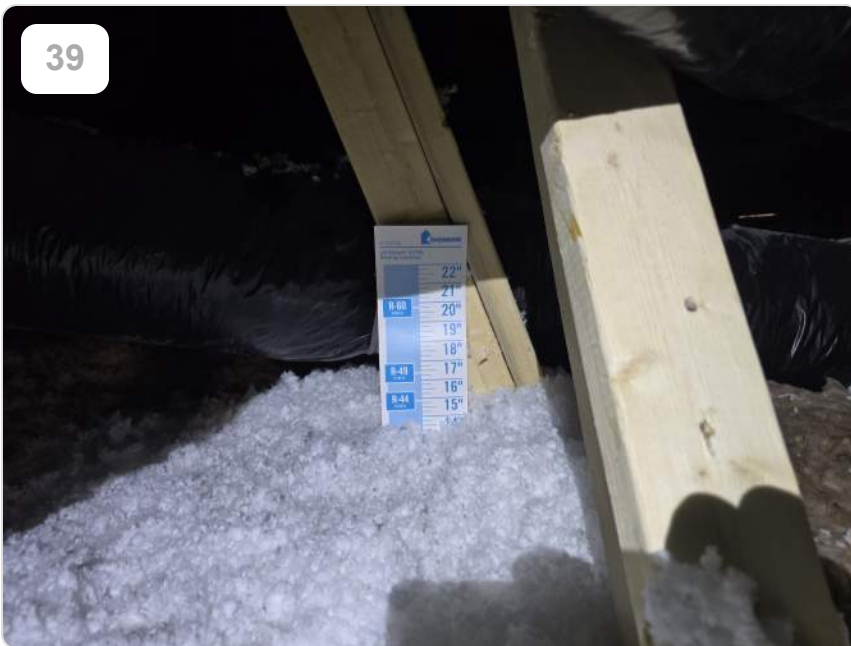
Moderate

**Status:** Monitor**Description:**

Attic insulation rulers indicated an insulation depth of approximately 14 inches, which would correspond to an estimated R-38 thermal resistance. Upon further inspection, however, the insulation depth was found to be approximately 9 inches. The insulation ruler had been bent upward at approximately the 4-inch mark, creating the appearance of greater insulation depth than was actually present. Based on the observed 9-inch depth, the attic insulation is estimated to provide an R-value of approximately R-30 to R-34, resulting in a deficiency of approximately 4 inches of insulation compared to the indicated R-38 level.

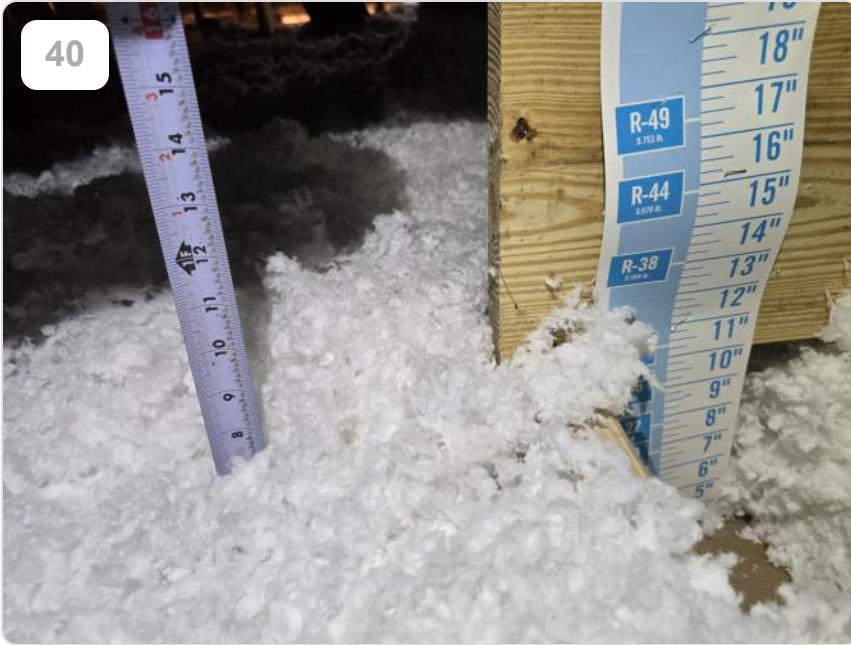
**Moderate****Status:** Monitor**Description:**

Attic insulation rulers indicated an insulation depth of approximately 14 inches, which would correspond to an estimated R-38 thermal resistance. Upon further inspection, however, the insulation depth was found to be approximately 9 inches. The insulation ruler had been bent upward at approximately the 4-inch mark, creating the appearance of greater insulation depth than was actually present. Based on the observed 9-inch depth, the attic insulation is estimated to provide an R-value of approximately R-30 to R-34, resulting in a deficiency of approximately 4 inches of insulation compared to the indicated R-38 level.

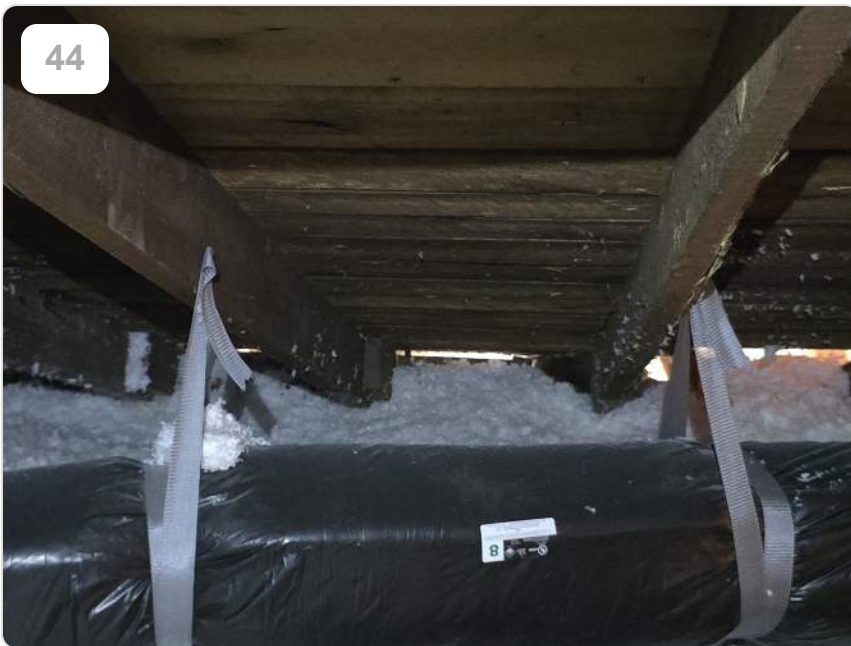
**Urgent**

**Status:** Needs Repair

Insulation was observed covering the majority of the soffit vents throughout the attic space, restricting proper airflow intake. Installation of insulation baffles is recommended to maintain clear ventilation pathways and promote proper attic ventilation.

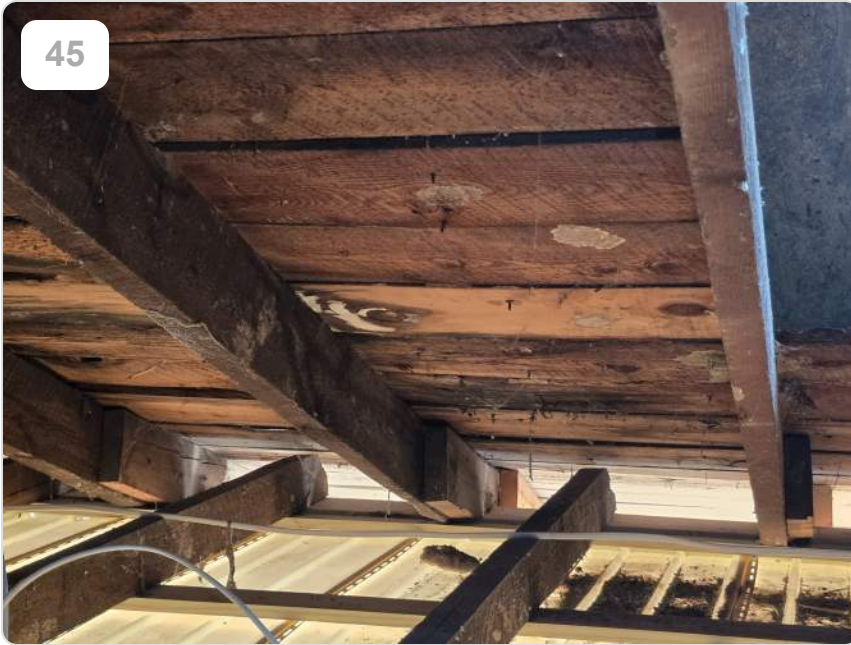
**Urgent**

**Status:** Needs Repair

Water damage and dry rot were observed in the roof decking along the dormer sidewall. The deterioration is consistent with prolonged moisture intrusion and should be repaired to restore the structural integrity of the affected area.

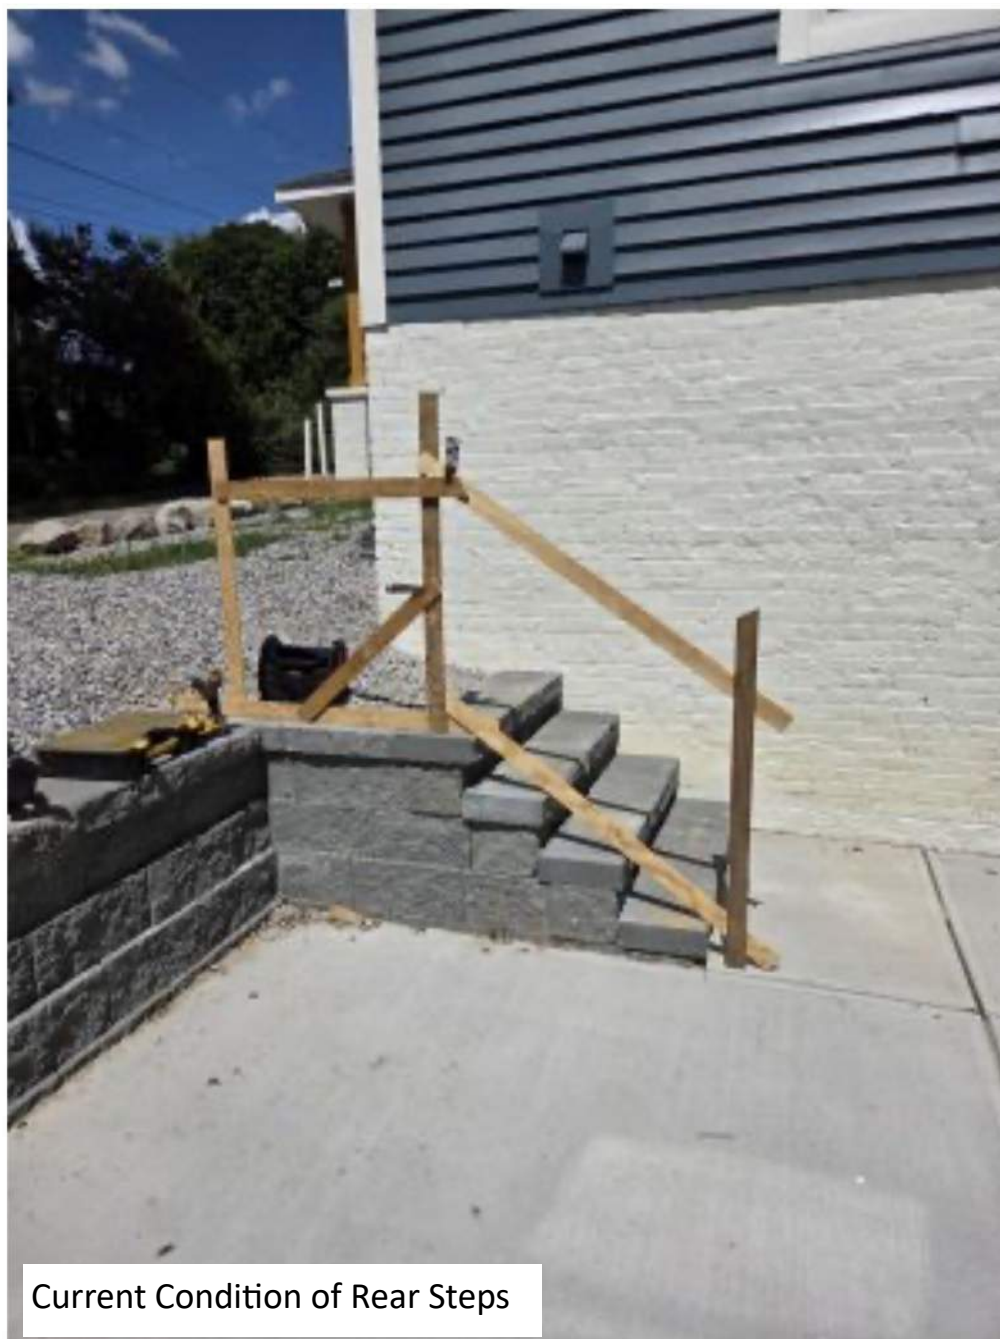
Current Condition of Rear Steps
